# Avonmouth Bridge Resurfacing

**Dave Sledge.**

**21<sup>st</sup> March 2013**

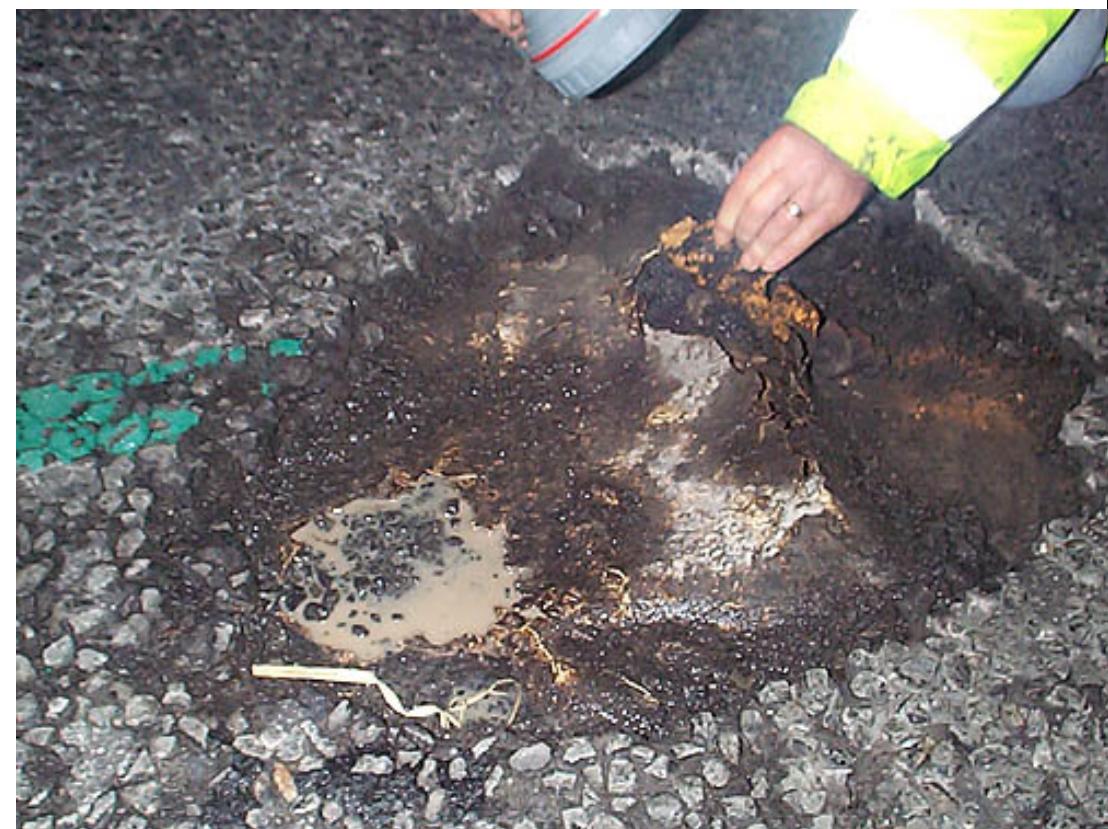
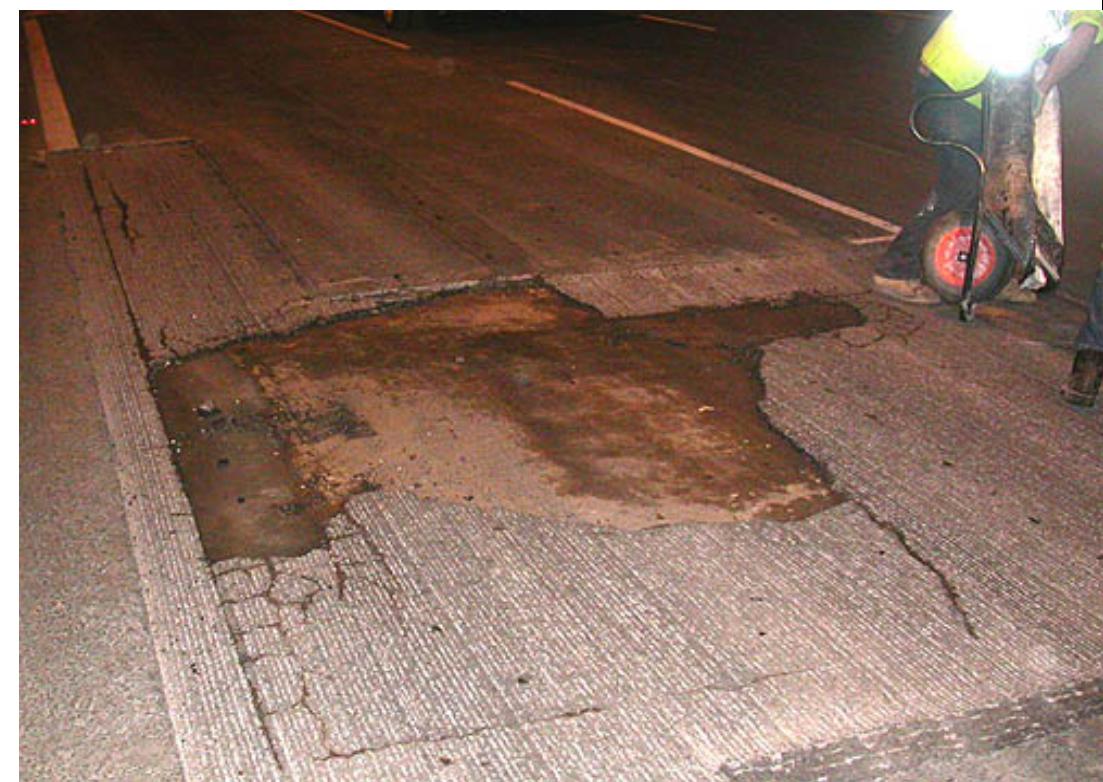
Last surface was hand laid

It had an Expected Life of 8 to 10 years –  
issues within 24 months

Porous nature of surface contributed to  
creation of pot holes

Bond between surface and waterproofing  
failing

Possibility of damage by welded deck  
repairs

Surface damage affecting waterproofing  
and could lead to damage to bridge  
structure beneath
