GEOSYNTHETICS & STEEL MESHES FOR LONGER LASTING ROADS

USER'S VIEW POINT: WHY WE USED THESE PRODUCTS

John Howe
Lincs Laboratory
Highways & Transportation
www.lincolnshire.gov.uk/lincslab

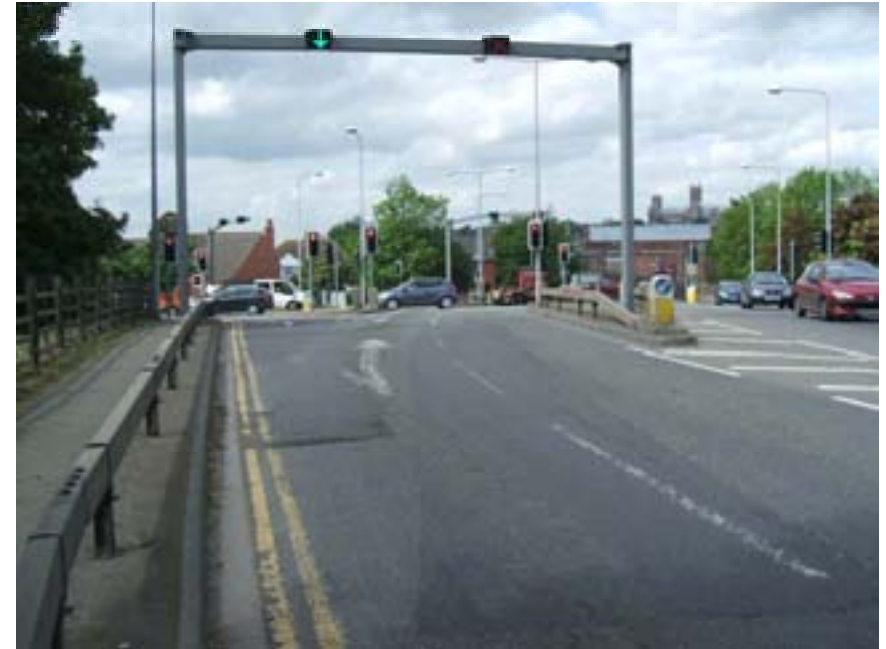
26 years later - May 2011

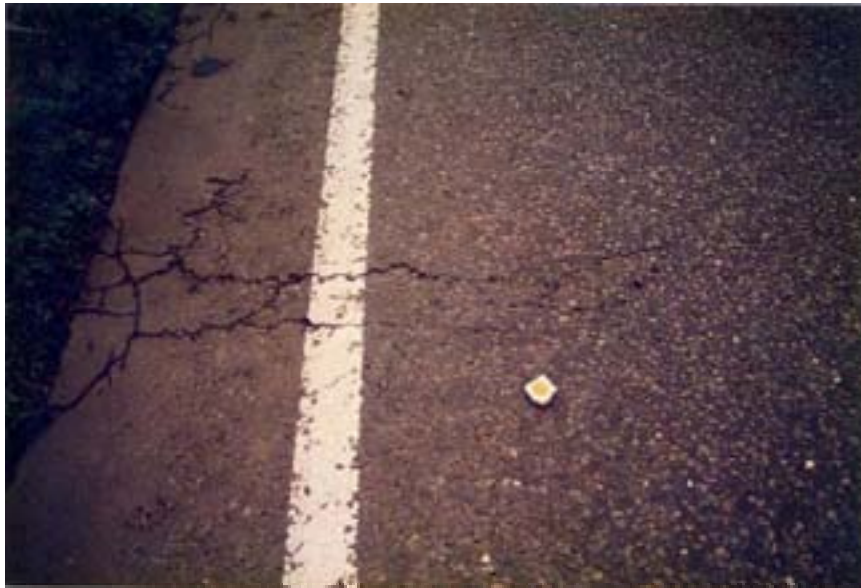
Tensor AR Reinforcement A1 North Witham (south bound) May 1986

Transverse/Reflective
Cracking associated with
Concrete Edge Beam

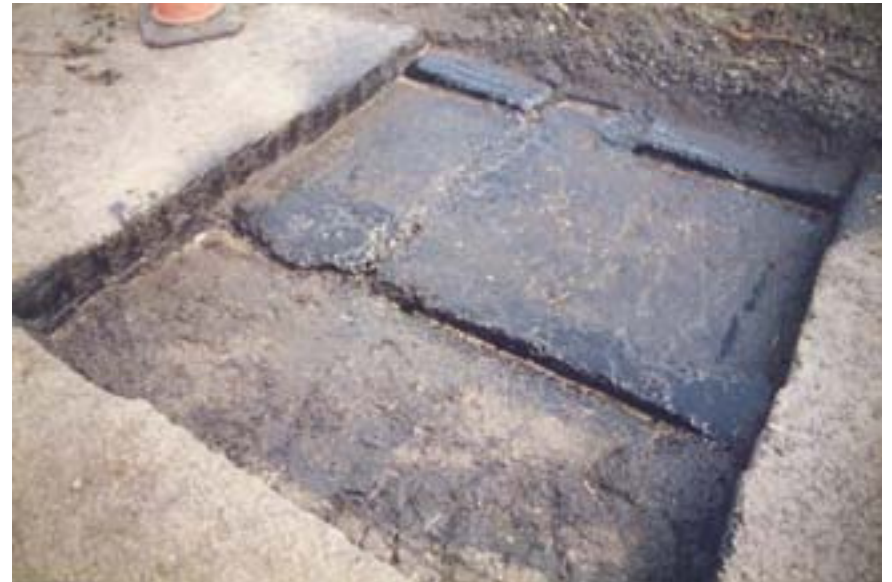
Repair - Preparation

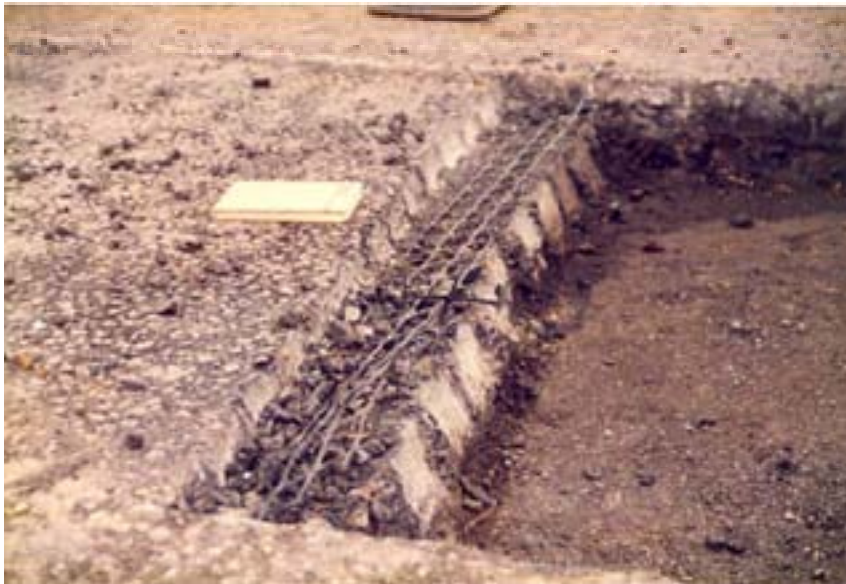
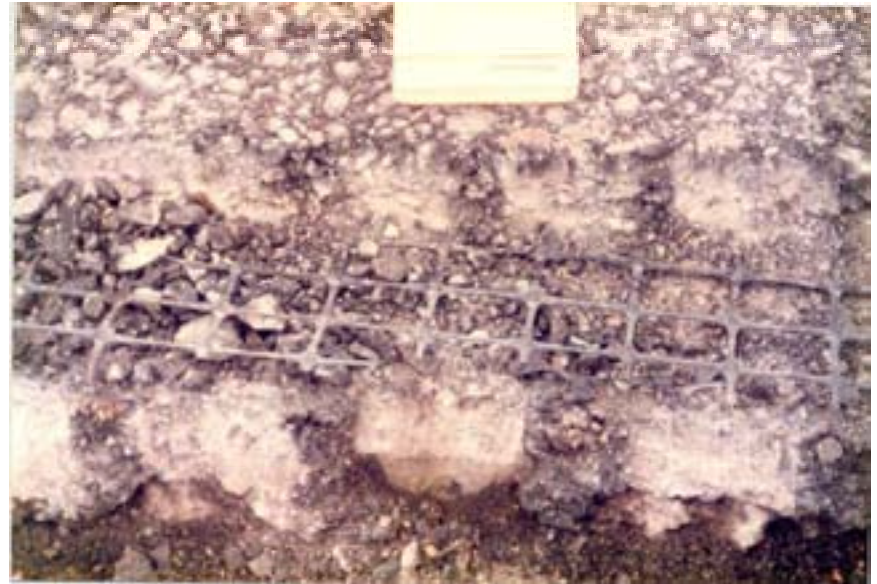
Tensor AR Reinforcement A1 North Witham (south bound) May 1986

Repair – AR Reinforcement sandwiched between two layers
of 20mm dense binder course

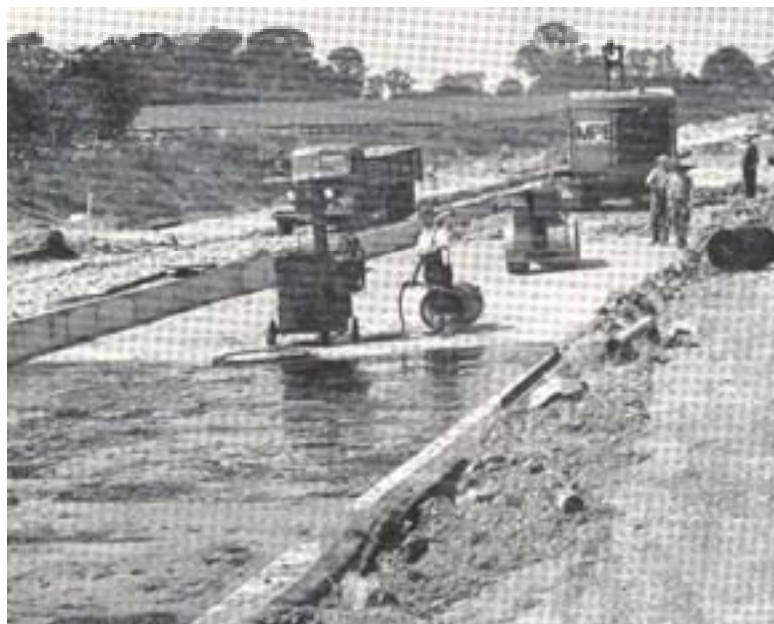
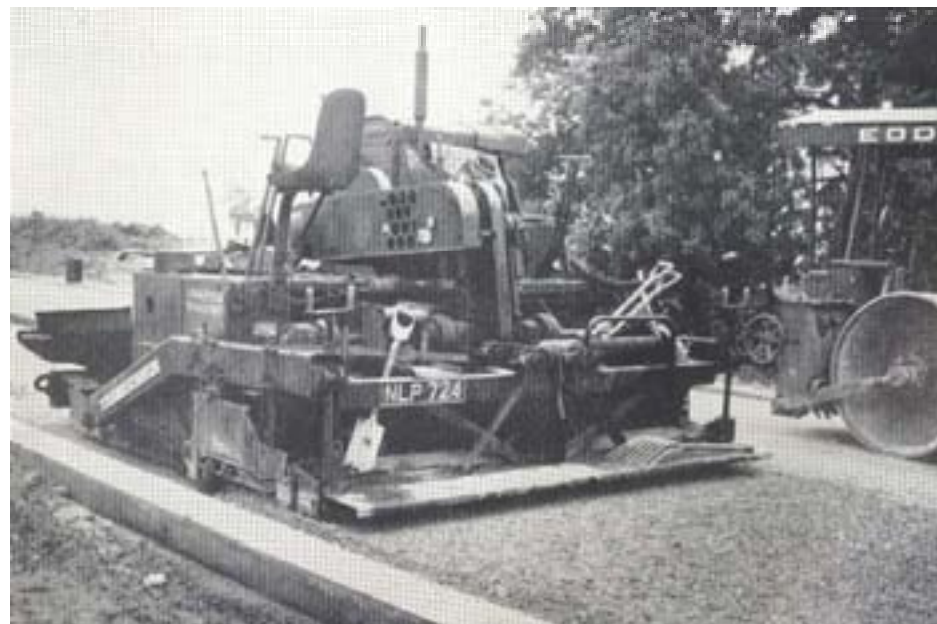
Transverse/Reflective Cracking Concrete Edge Beams

To provide:

- Edge Restraint
- Vertical Level Control

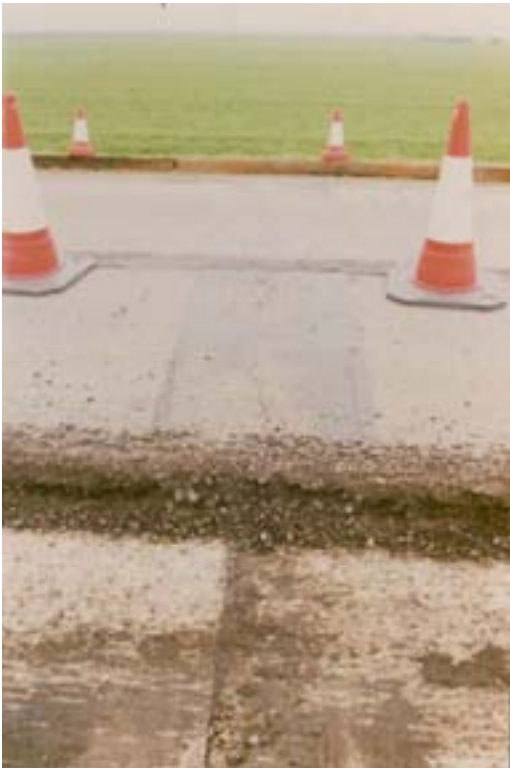
Exposed concrete slab,
transverse joint &
surface condition of
adjacent carriageway
surface.

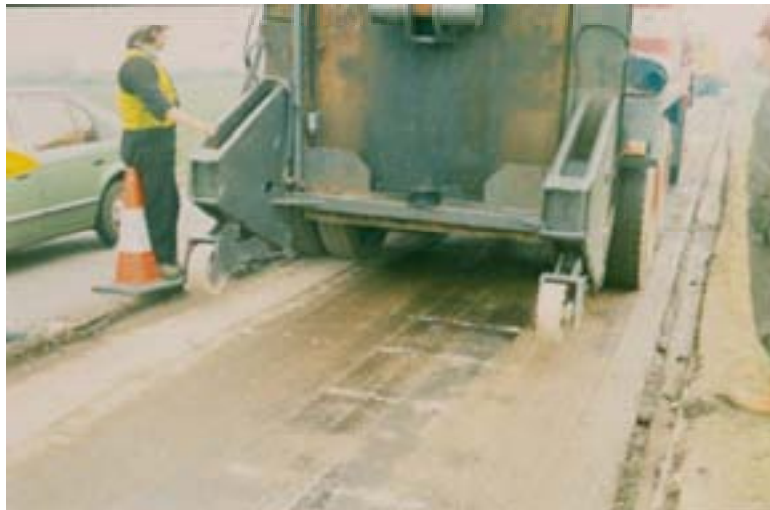
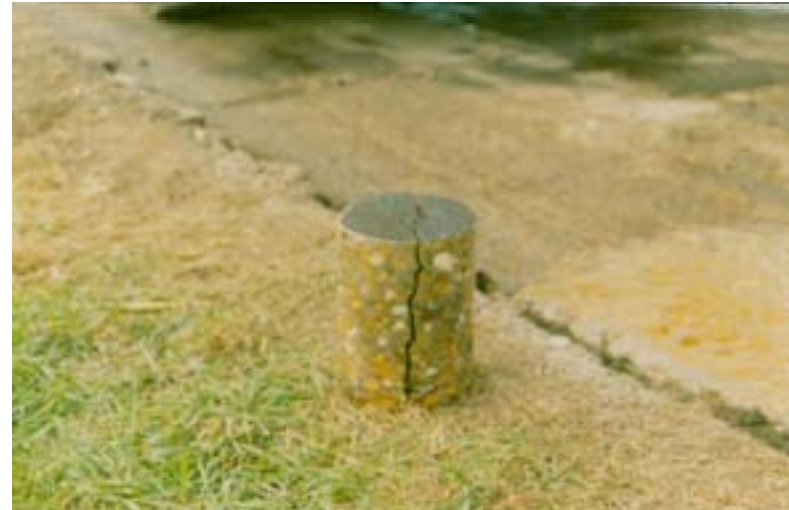
“Crack & Seat” Technique

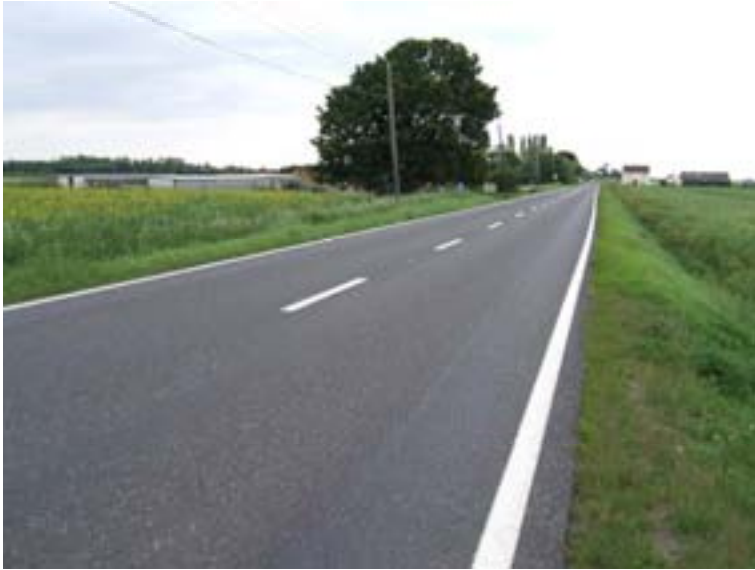
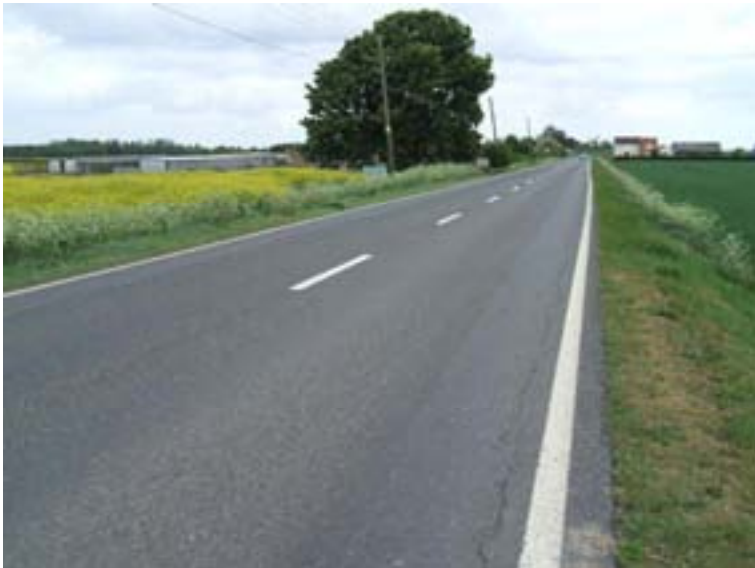
Condition 15 years later
(June 2008)

Maintenance since Summer
1993:

- Western half of site patched & surface dressed Summer 2003
- Eastern half of site patched & surface dressed Summer 2004.

Condition 18 years later
(May 2011)

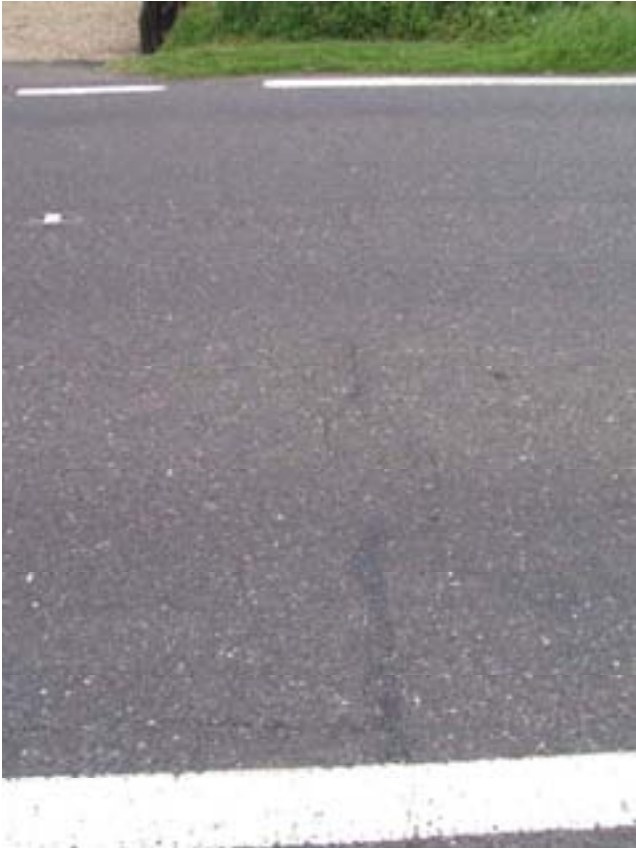
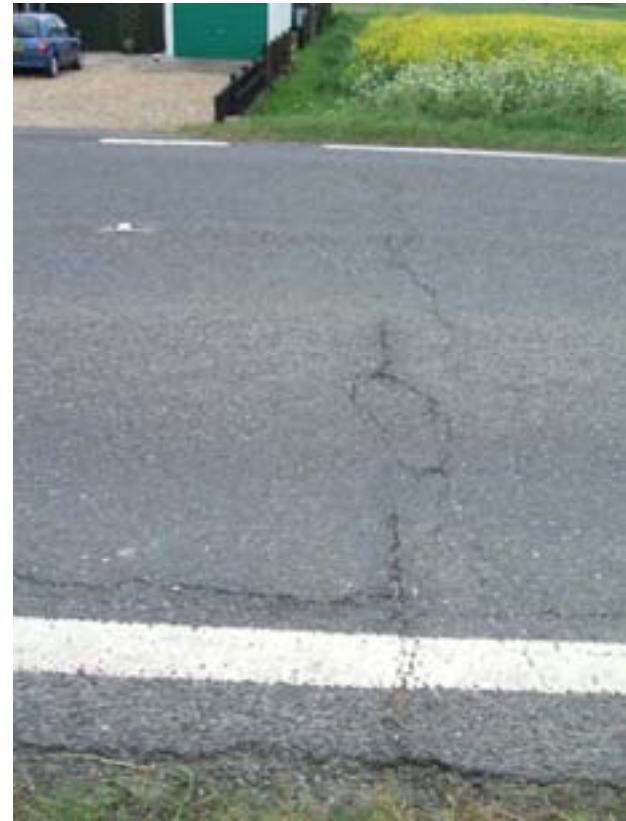
Transverse cracking appearing at isolated locations (June 2008)

Condition 15 years
later (June 2008)

Condition 18 years
later (May 2011)

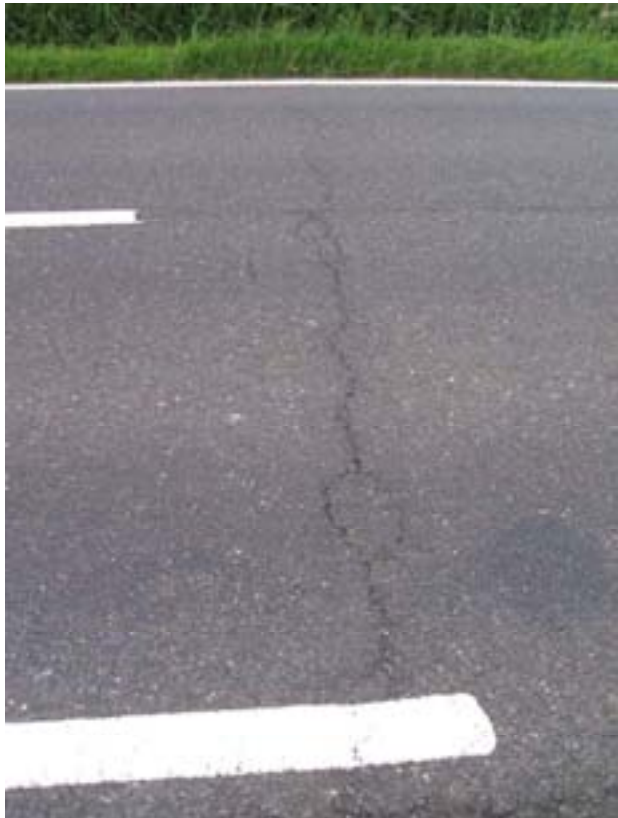
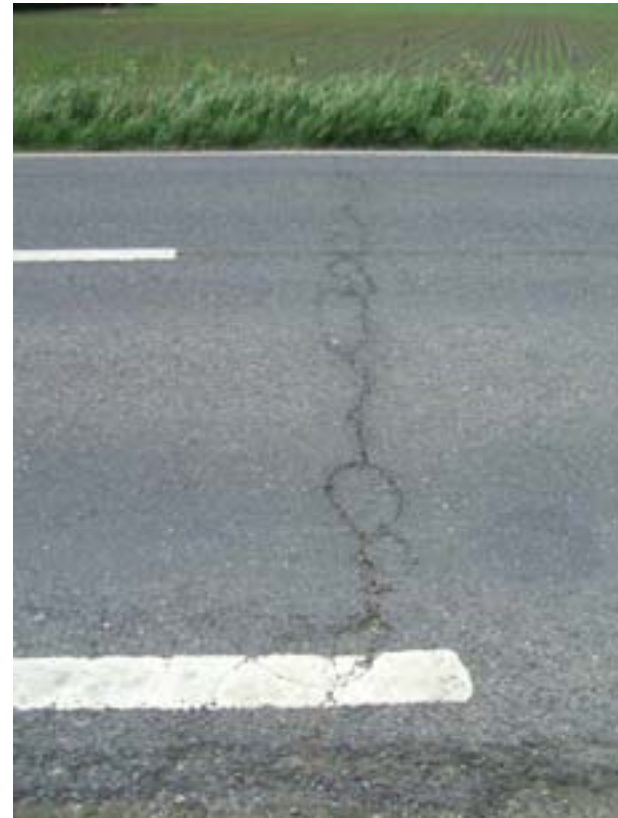
Transverse cracks and longitudinal edge cracks are visible at intervals. The majority of the carriageway surface appears sound (May 2011).

Condition 15 years later (June 2008)

Condition 18 years later (May 2011)

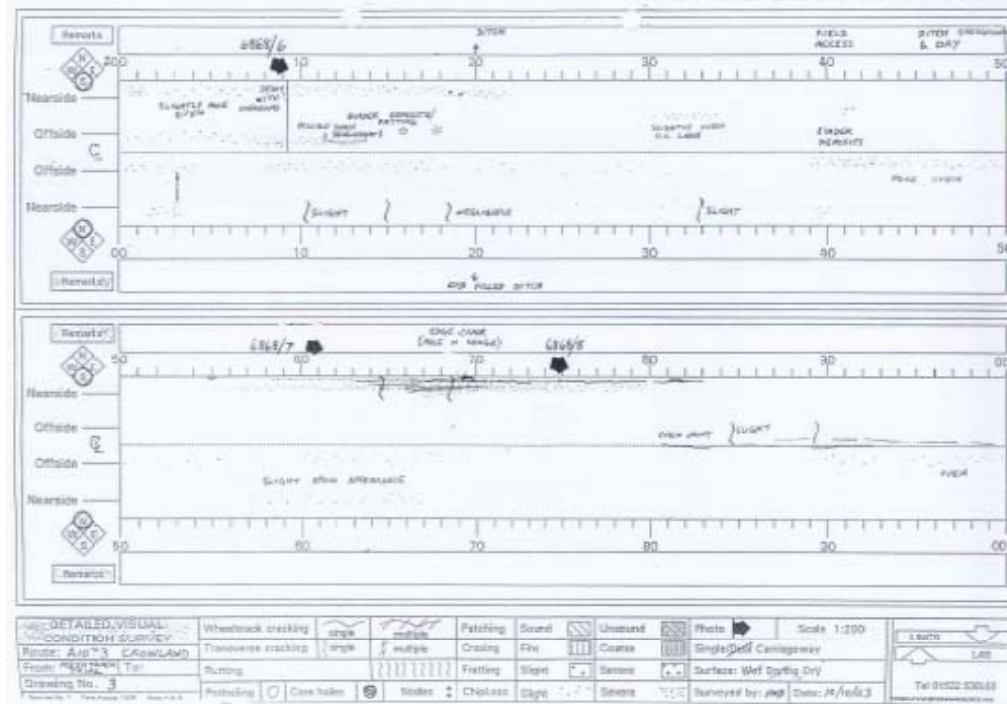
- Several locations in section with minimum treatment G have reached failed condition.

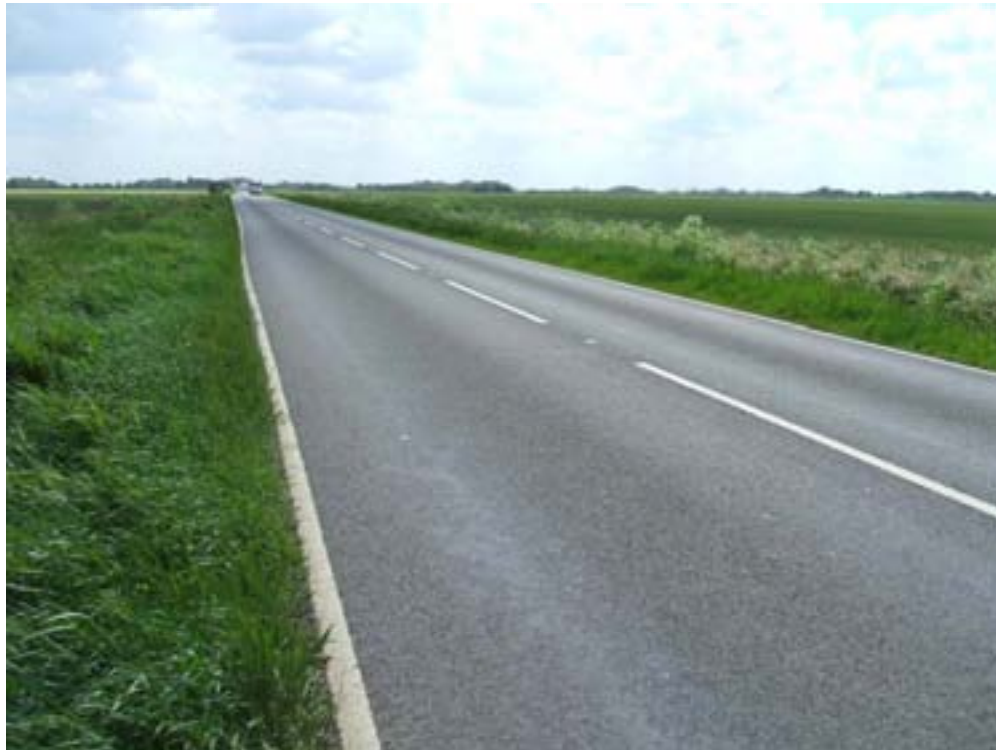
June 2008

Maintenance work
carried out
August/September
2004

- Plane off 50mm
- Proposed to replace with 100mm dense binder course. Actual thickness 70mm to 95mm.
- Surface dressed.

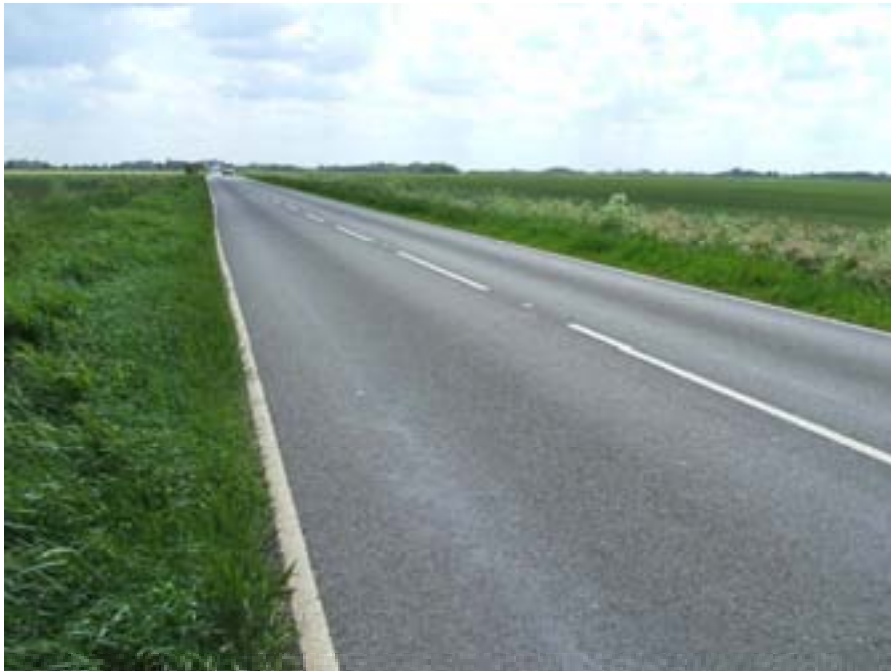
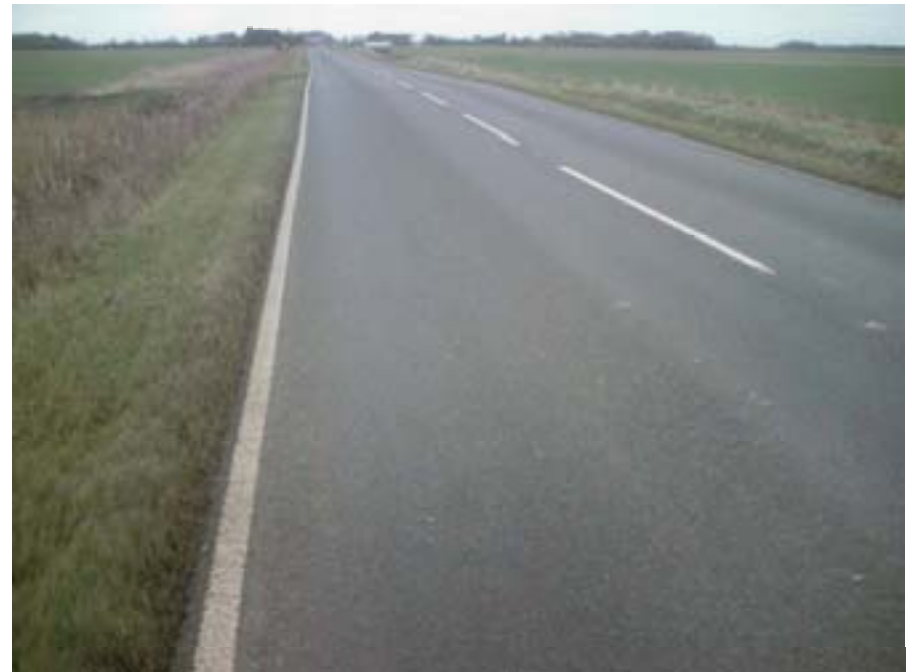
- The majority of the trial section appears sound, particularly with respect to the thicker construction options (A to F) including those with two meshtrack layers and cement bound base.
- The length treated with 75mm of binder course and one layer of grid (option G) exhibits localise nearside cracking in one area of the northbound lane and occasional longitudinal edge cracking.
- Some opening of the centre joint is also apparent in addition to wheel path deformation.
- A 30 metre maintenance patch is also included across the full carriageway width.
- A transverse reflective crack is situated at the transition from cement bound base to treatment G.

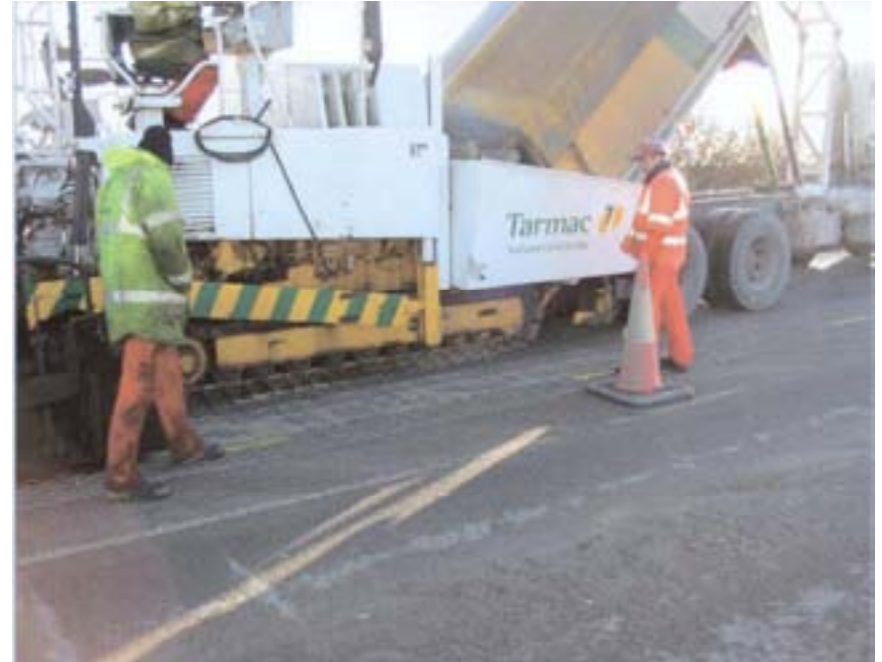
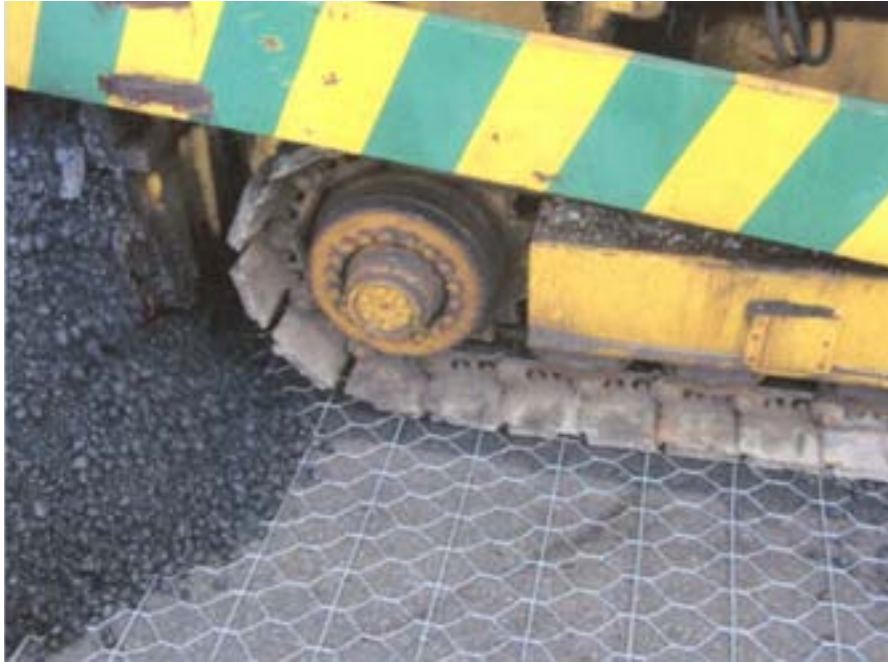
Tracked paver is essential
