Lessons that can be learned from hot climates

Colin Jones Principal Engineer, TRL. March 2012

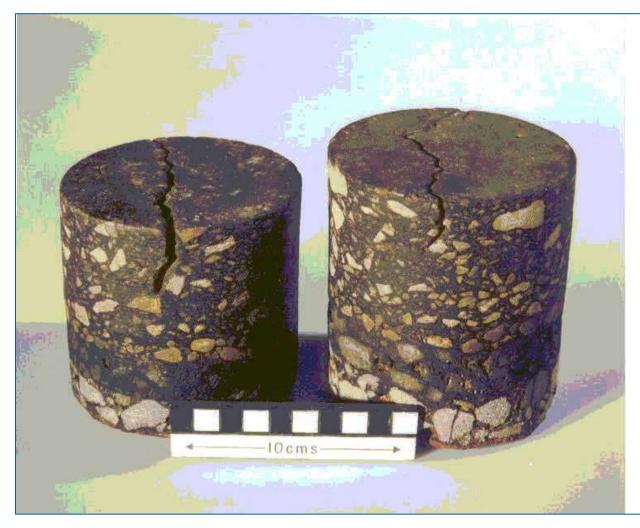
1974

`Top-down' cracking in asphalt concrete – 1970's

- First asphalt concrete overlay laid on the national network , Kenya
- Nairobi Mombasa Road
- Research showed that cracking resulted from ageing of the binder at the surface

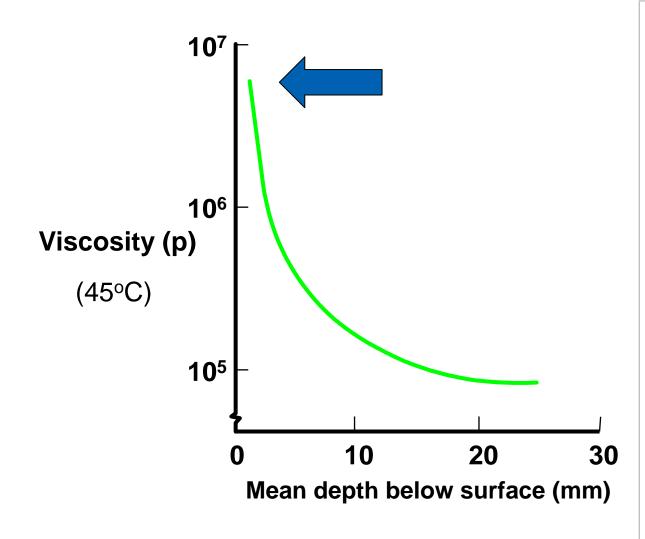
`Top-down' cracking in asphalt concrete – 1970's

- Sliding Plate
 Viscometer
- Viscosity in top 3mm 2 orders of magnitude higher than lower in the core
- 'Brittle' failure at asphalt surface causes cracks to start
- Strains could result from temperature changes or traffic
- BUT all cracks in the asphalt overlays were found to start from the top

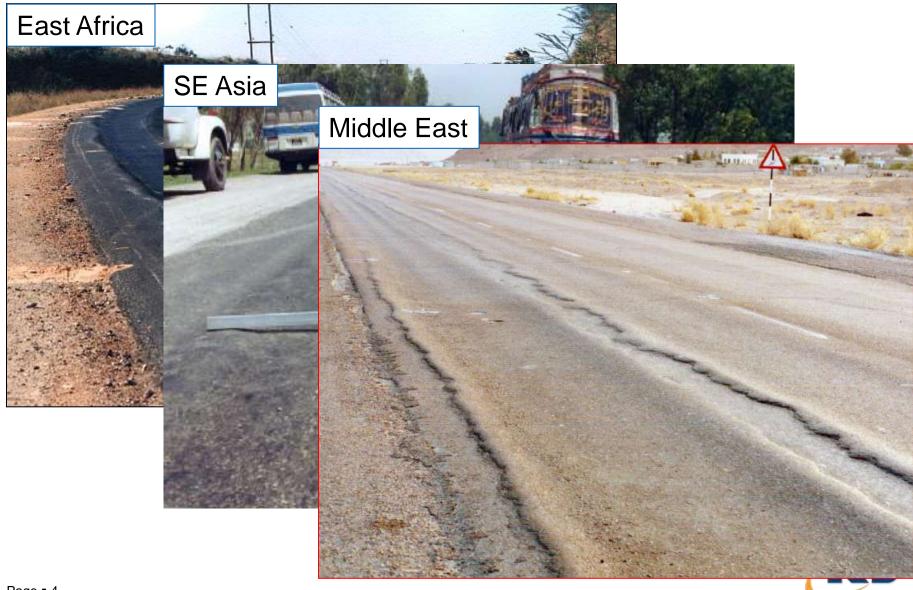
Deformation in asphalt concrete – 1980's

Was it due to excessive loading?

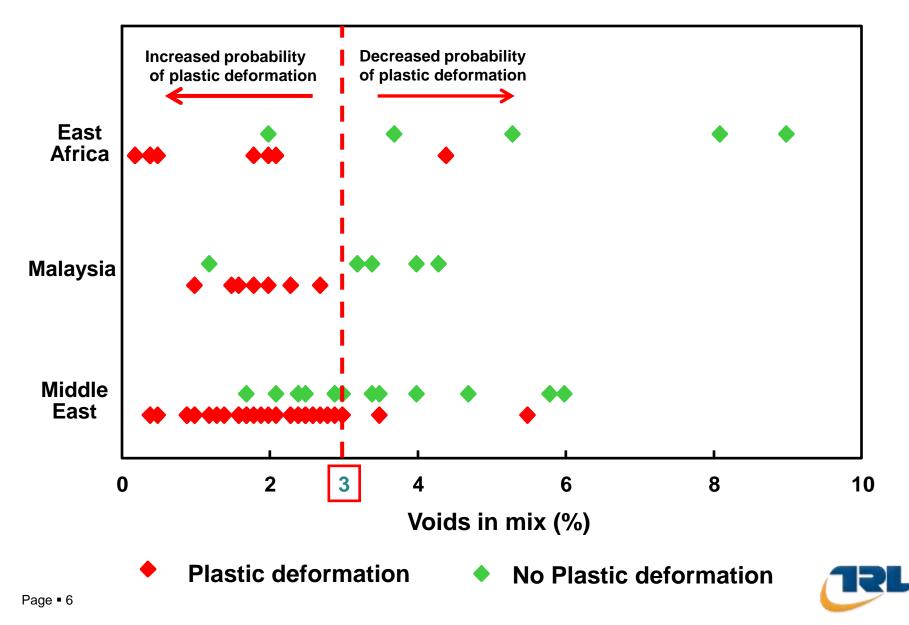
'Secondary compaction' in asphalt concrete

Revision of AI asphalt concrete design standards

MS-2 Voids >3% after trafficking?

SUPERPAVE Gyratory compaction for different levels of traffic

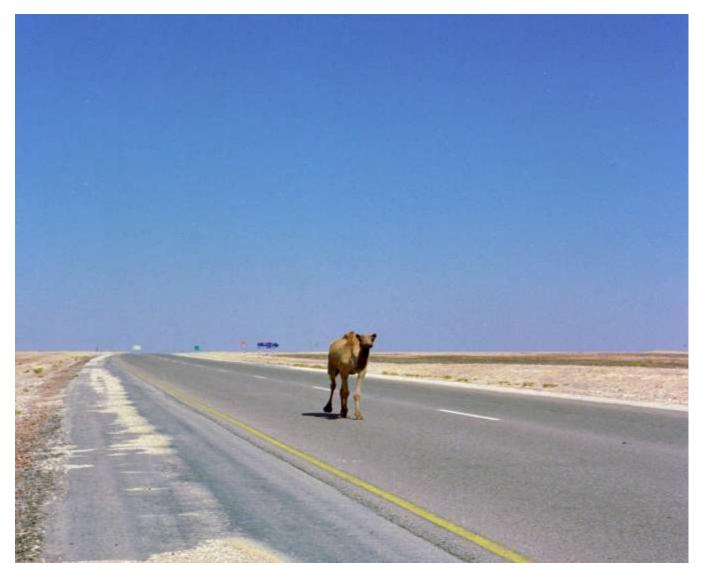
Asphalt concrete in desert regions

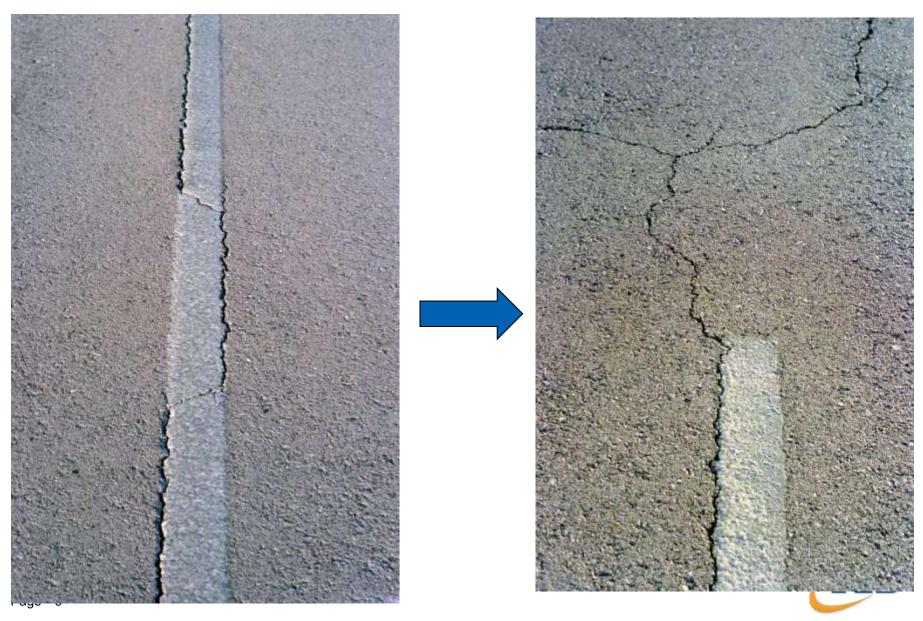
Asphalt concrete in desert regions

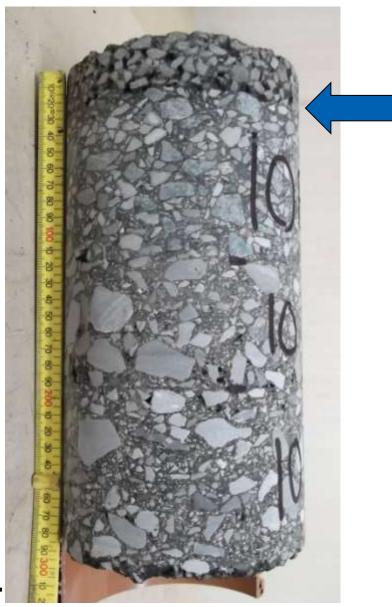
Illustration of Holding Do Something approach - 2

Holding Works
